LARGE CULVERT STUDIES IN MONTANA

Prepared for
Montana Highway Commission
Planning Survey Section
in cooperation with
U . S . Department of Transportation
Bureau of Public Roads

Alfred C . Scheer

1968

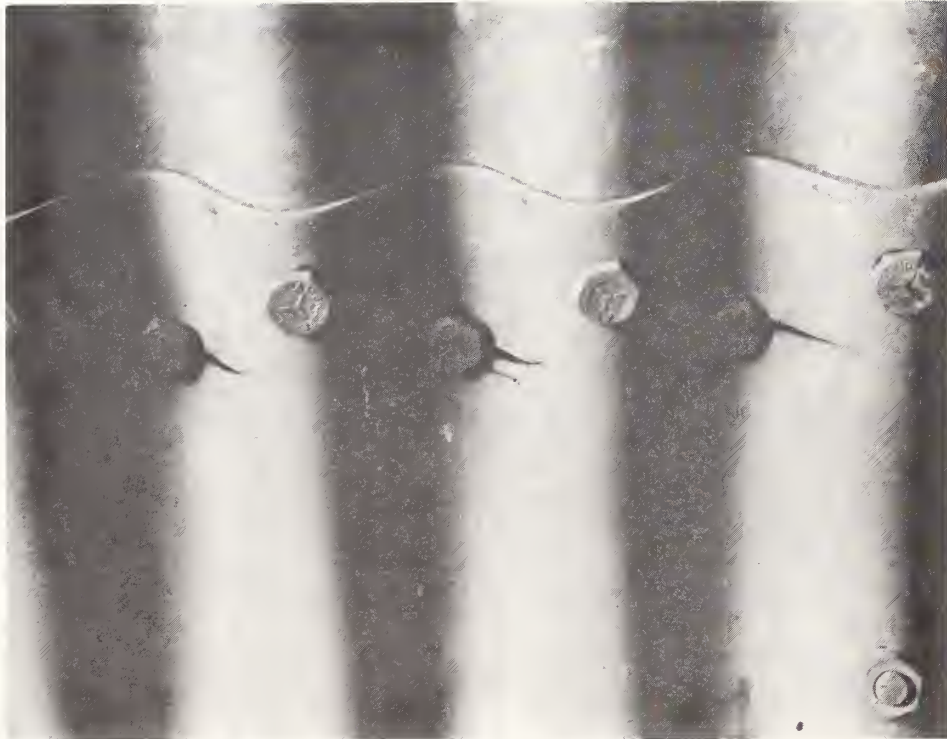
Excessive bending moments are generated in the corner regions of pipe-arches unless the lateral earth support is particularly firm and unyielding. In circular or elliptical culverts, the generated moments will be smaller, and the needed lateral earth support can be mobilized easier because the pipes can bulge farther, laterally, without serious structural consequences. In a pipe-arch, the relatively flat floor acts like a tie and limits the extent to

FIGURE 44. CRACKED PLATES IN THE EMIGRANT
CULVERT (PROJECT CULVERT NO. 1)

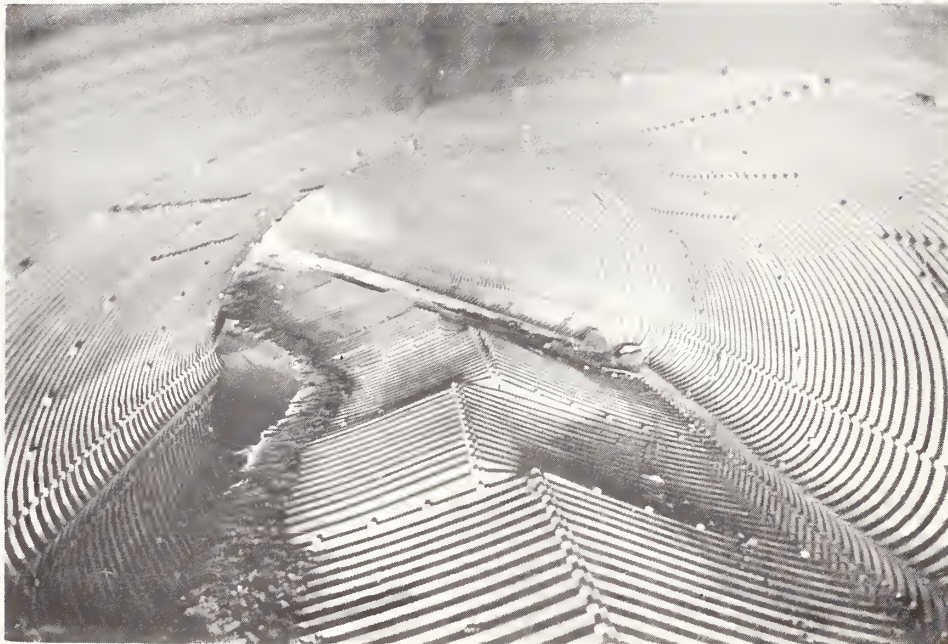
Ostensibly , a floor that buckled upward , from a centrally concentrated floor reaction , would pull the culvert sides inward . At least there would be no need for the sides to bulge outward significantly in such a case . The large amount of outward bulging that has occurred in culvert 7A is indicative of a lack of rigid lateral support , whether or not one chooses to believe that poor lateral support was responsible for the buckling .

FIGURE 45. BUCKLED FLOOR OF PROJECT
CULVERT NO. 7A, NEAR BUTTE
The plates are also cracked along the corner seams
on each side.
